Inquest into the death of Thomas Hunt and Youngeun Kim

Coroner Nerida Wilson conducted a joint inquest into the deaths of Thomas Hunt and Youngeun Kim who died in separate events two years apart at Josephine Falls, located in the Wooroonooran National Park. The coroner investigated measures that could be implemented to minimise the risk of water related fatalities at Josephine Falls.

Recommendation 2

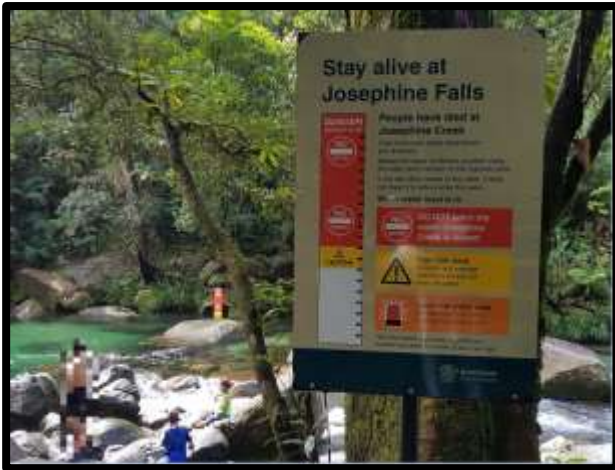
Sign and gauge post installed at the bottom pool.

The water gauge markers visually represent the risk levels at different swift water heights so that people can see when the risks are too high to enter the water. The water gauge markers are colour coded and use standard warning symbols for those with non-English speaking backgrounds. The flashing alarm system connects to water level monitors and activates when water conditions reach a pre-defined level which is considered to be unsafe, or when levels are likely to reach the unsafe level within the next 10 minutes.

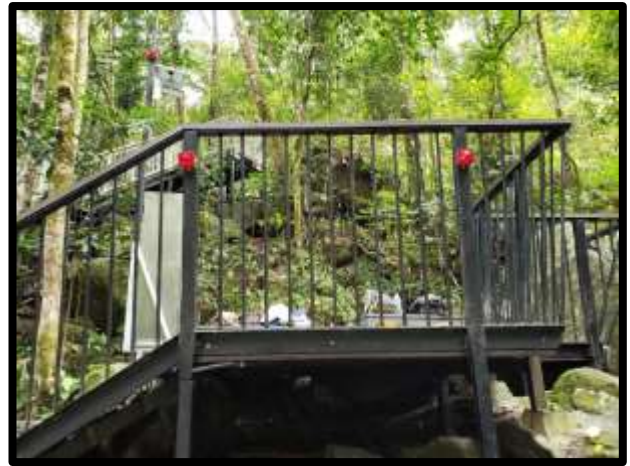
The platform at the lower pool, showing three of the four beacons installed at that location

The alarm system provides an additional measure to the water gauge markers to alert people on the creek bank of the risk of entering the water, and for people already in the water who may be unaware of the changing conditions.

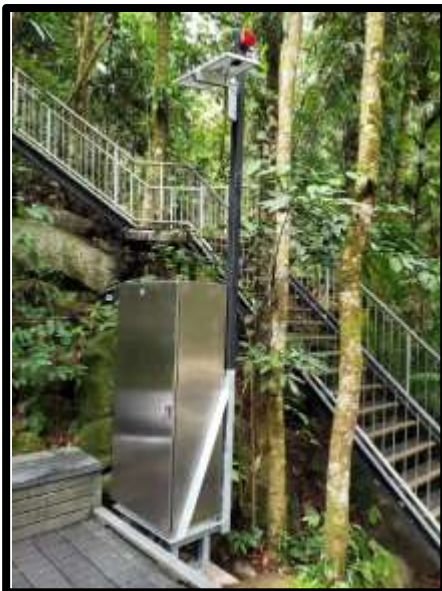
The cabinet at the lower pool, containing the main controller for the warning system.

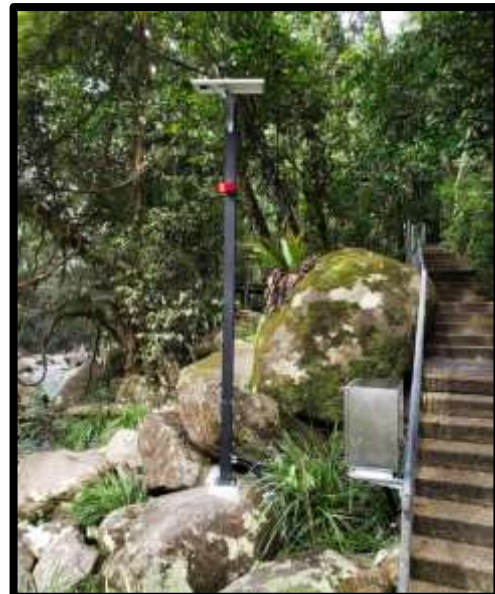
The cabinet at the middle pool, containing the second controller for the warning system.
